**PNRF BARKING SANDS
CABLE INSPECTION 1983**

**FPO-1-83 (39)
OCTOBER 1983**

**ROBERT TAGGART INCORPORATED
FAIRFAX, VIRGINIA**

**OCEAN ENGINEERING AND CONSTRUCTION PROJECT OFFICE
CHESAPEAKE DIVISION
NAVAL FACILITIES ENGINEERING COMMAND
WASHINGTON, D. C. 20374**

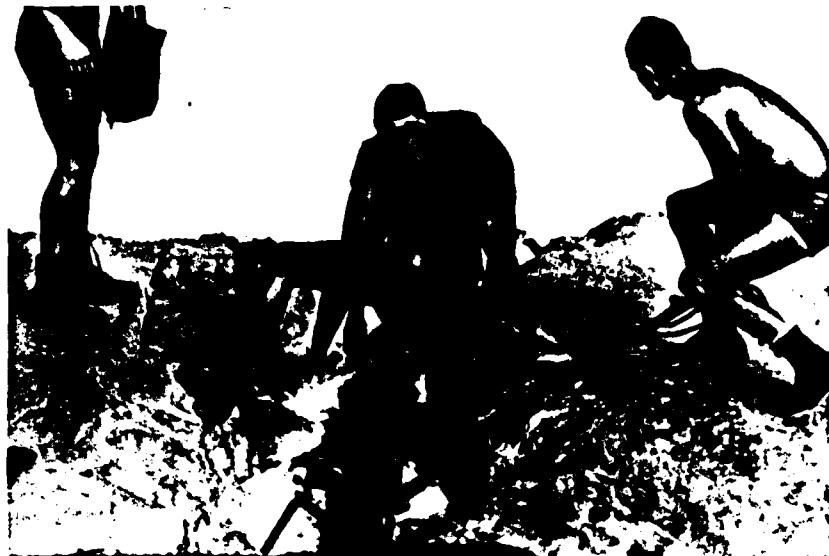
FIGURE 2-2

UCT-TWO PERSONNEL
PRY UP CABLE TO INSTALL
A NEW SECTION OF
PROTECTIVE SPLIT PIPE

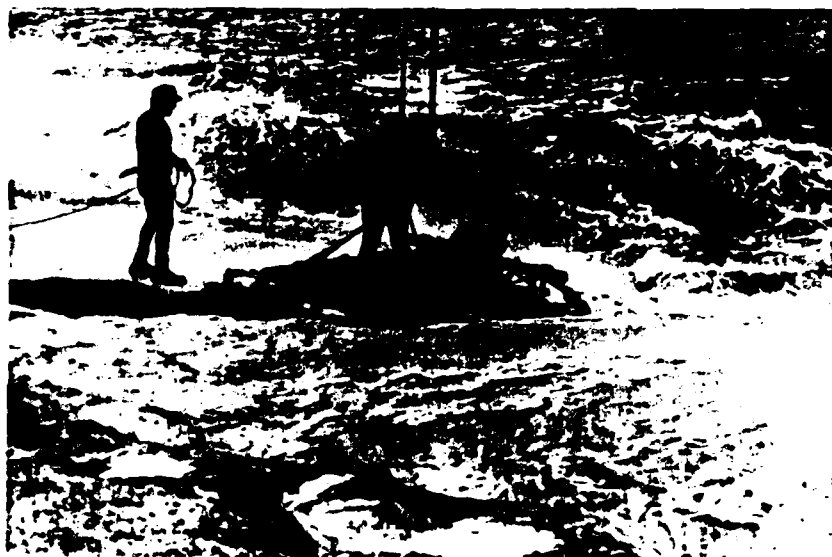
FIGURE 2-3

This operation was also unsuccessful. The pallets and anchors were readied and lowered into position using a PMRF crane. But the surf proved so strong that it actually caused the pallet to move across the beach rock even when weighted down. The operation was halted and the anchor and pallet recovered.

PALLET WITH 5000#
ANCHOR ATTACHED WITH
CARGO NET LOWERED
OVER BSURE TRENCH.
OPERATION HALTED WHEN
SURF MOVED PALLET
AND ANCHOR.

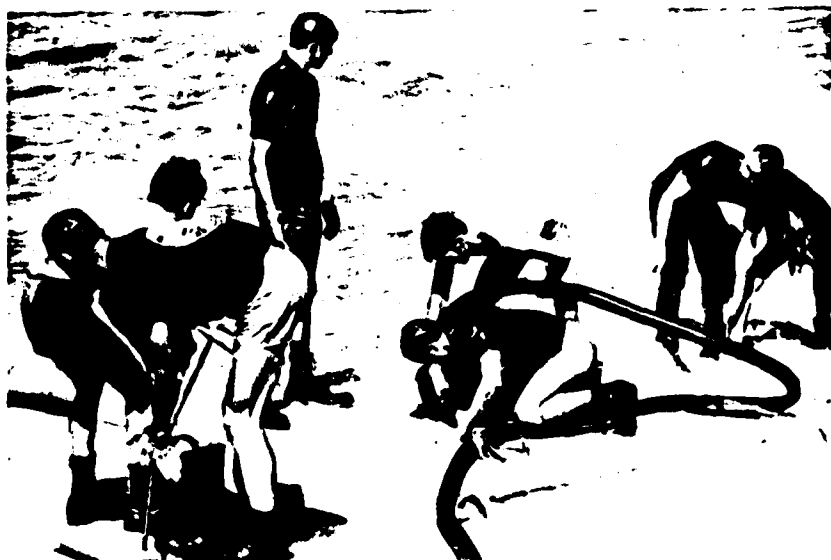
FIGURE 2-9

PUMPING CONCRETE THROUGH
PORTS IN SLABS TO FILL
TRENCHES UNDERNEATH
